Using VEKA Plc products in high exposure areas.

Additional measures to further improve performance.

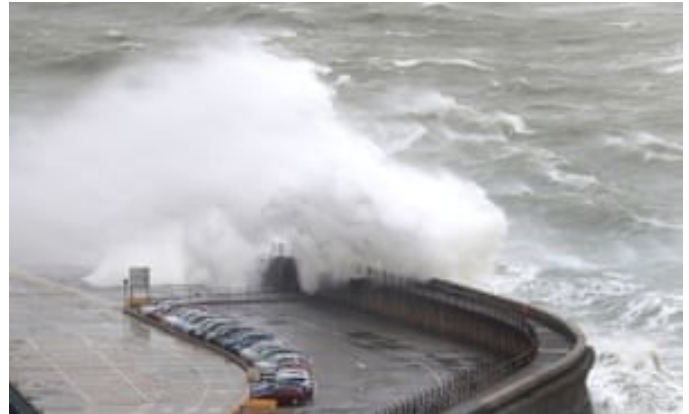
There are many causes for water ingress in such situations, the glazing maybe at a minimum tolerance on width and reduce the pressure from the gaskets, there may be hard spots on the gaskets from the welding of the profile or the product may not be reinforced to the correct standard.

Windows are not 'submarine' tight! Water can pass beyond the gaskets and this happens more often than you think it would, but as a homeowner you do not see it. This is because window designs include drainage routes allowing any water that has breached the gaskets to run safely back to the outside of the building before it can reach the internal areas. Sometimes though, in the extreme conditions described, the drainage does not have an opportunity to work fully before the water shows on the inner face of a building.

Any hard spots in the corners of the gasket must be removed as part of any remedial work, it is also important to ensure there are pressure equalization holes in the frame to allow the drainage to work properly. Imagine filling a straw with water and keeping your thumb over the top, the water can't escape. Remove your thumb and the water flows, pressure equalization works in a similar way

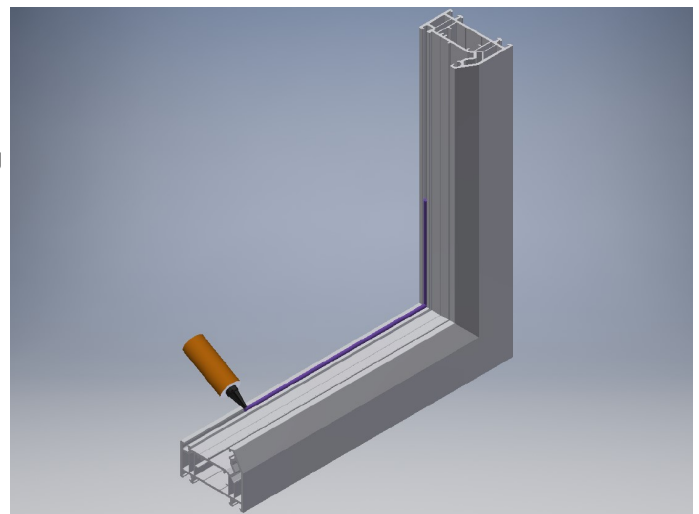
An alternative method when glazing with an internal bead would be to use a good grade silicone and apply a continuous goalpost around the base and up the sides of the internal face of the bead groove to a height of 100mm. Be careful not to get the silicone on the glass as it may affect coatings. Once the silicone is run replace the beads as normal. This has a similar effect to externally beaded as it has increased the height the water has to travel before it can seep through and therefore allows the drainage routes to work fully.

Ideally a window positioned in such a location would be externally glazed. The glazing beads are clipped into place on the profile so when water is able to breach the gaskets an internally glazed bead has less chance to stop that water passing through to the inside, it simply builds up and seeps through the bead leg showing as a fine line of water.

If the bead is on the outside then internally the glazing gasket would be some 20mm above the profile and therefore water would have to rise by a similar dimension before it can seep through. So externally glazed will allow the drainage to do what it is designed to do.
